POTOMAC RIVER BASIN

**Name Of Dam:** OCCOQUAN RESERVOIR SYSTEM

**Inventory Number:** OCCOQUAN "UPPER" MAIN DAM, VA 15304  
OCCOQUAN "LOWER" STORAGE DAM, VA 15305

## PHASE I INSPECTION REPORT NATIONAL DAM SAFETY PROGRAM

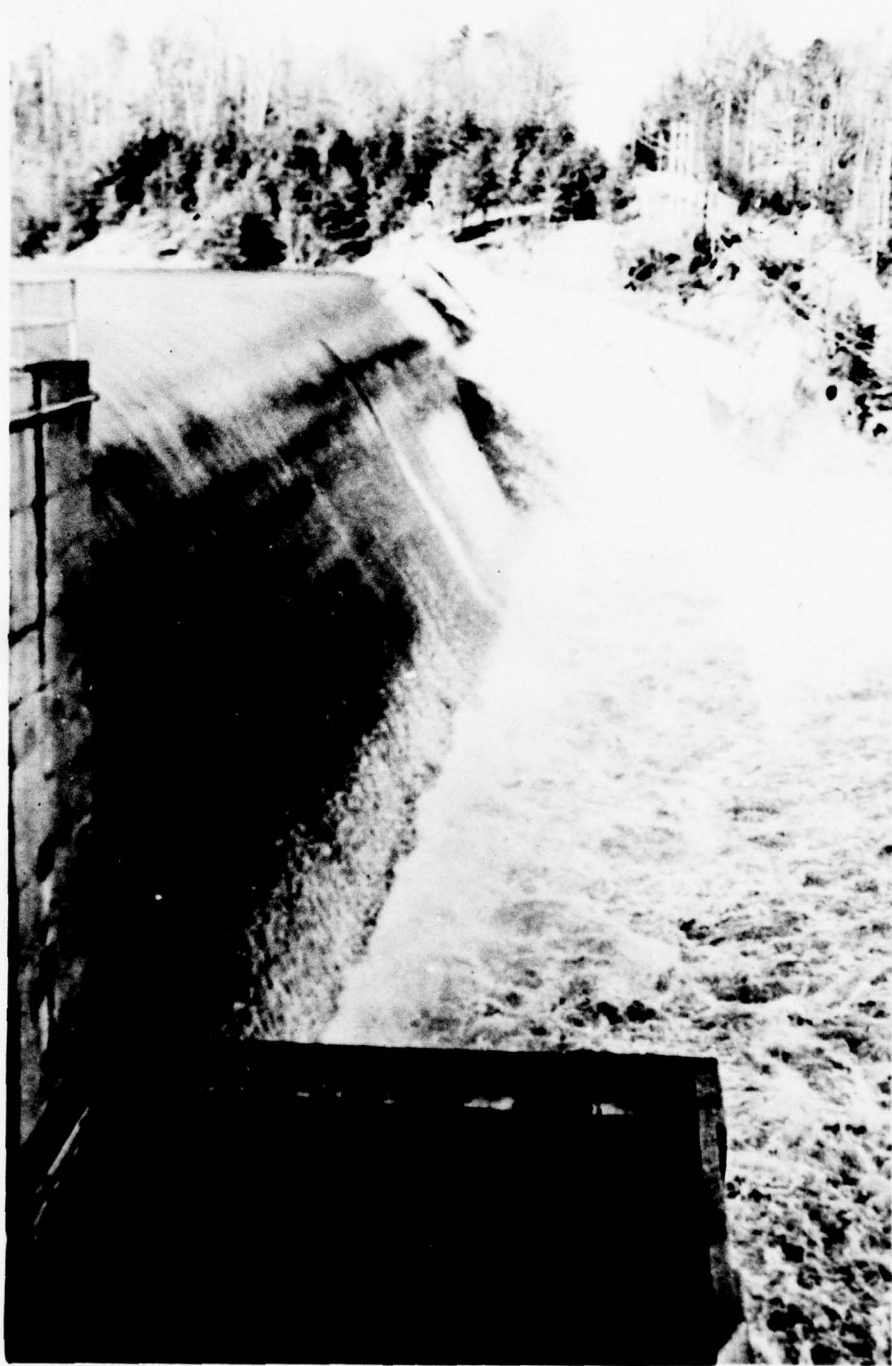
SPILLWAY AND LEFT ABUTMENT  
UPPER DAM

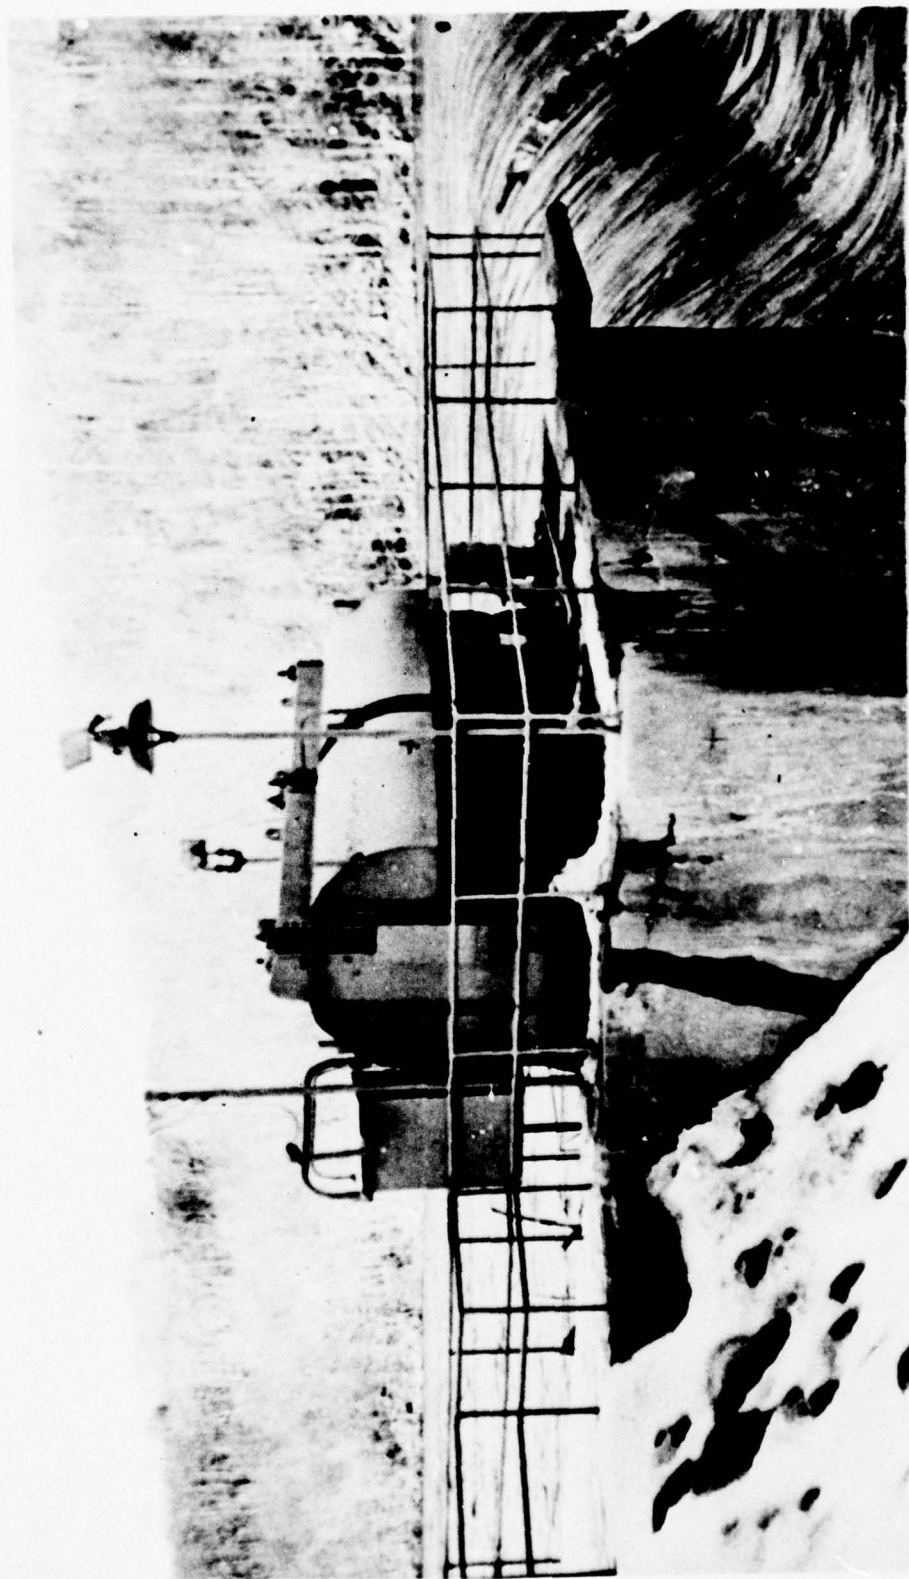
INTAKE STRUCTURE  
LOWER DAM

Water was flowing freely over the length of the lower dam. The high water was overtopping the trash screen in the intake structure at elevation 57 MSL. The left abutment could not be directly observed due to wet conditions and difficult access. Based on observation from the right abutment, the left end of the dam was barely visible due to the high flows. It appears to tie into rock. On the right side, the dam ties into the intake structure. A wing wall extends from the intake structure and ties into a riprapped abutment.
